KBR-500

Feed Gap Adjustment

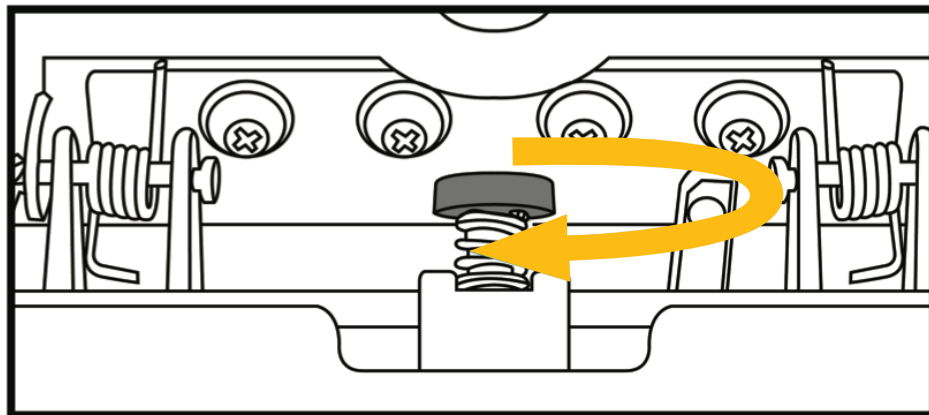
During transportation or the normal course of operation, the feed mechanism's adjustments might become altered, potentially resulting in errors such as DOUBLE or CHAIN errors. These errors occur when the feed gap, which is the space within the bill feed path, is improperly set. Ideally, this gap should be equivalent to the thickness of a single bill. A feed gap that is too large can cause a significant increase in DOUBLE and CHAIN errors, as it allows multiple bills to be fed into the scanning path simultaneously. Conversely, a too narrow feed gap can prevent bills from entering the scanning path or may cause the mechanism to catch and tear the bills.

1. Make sure the unit is powered off before proceeding.
2. Find the feed gap adjustment knob, which is located at the back of the unit.
- 3(a). If the unit is pulling in multiple bills at once, leading to DOUBLE or CHAIN errors, you should tighten the feed gap. This is done by turning the knob clockwise. Adjust by making a half-turn, then test the unit to check if the issue is resolved. Continue adjusting by half-turn increments and testing as needed until the problem is fixed.
