# SIGNATURE

## Feed Gap Adjustment

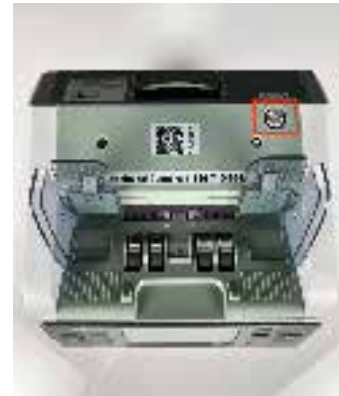
1. Make sure the unit is powered off before proceeding.
2. Find the feed gap adjustment knob located on the top panel (as shown on the diagram to the right).
3. Turn the knob clockwise or counterclockwise, as follows:

**3(a).** If more than one bill is being pulled through the bill feeder at a time (causing Double and/ or Chain errors), tighten the feed gap by turning the knob counterclockwise (towards the "-" mark).

**3(b).** In case of Chain errors or bill jamming, loosen the feed gap by turning the knob clockwise (towards the "+" mark).
